**Appendix 2. Photo Survey, Safety and Compliance Audit - Lane Cove Rd to Talavera via Fontenoy**  
 (Nothing in this report indicates that cyclists accept this route as a reasonable or safe alternative to the existing M2 cycle facility.)

This is Appendix 2 of the Bike North Audit of the M2 Interim Bicycle Detour as proposed by Transurban. It covers the section from Lane Cove Rd to Talavera Rd via Fontenoy Rd providing access from the north. Other appendices will cover various sub routes and options that were suggested. This document should be read in conjunction with the other documents.

Principal Auditor : Doug Stewart (Bike North). Audit Date: 16 January 2007.

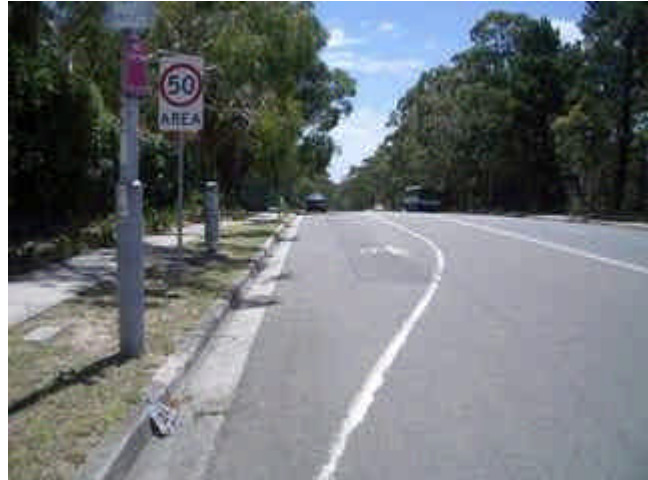
| | Location | Comments | Work |
|---|---|---|--|
| | 1. Fontenoy Rd (facing west) | Start of the on-road route with a wide bike lane and 50 kph speed limit, which should be the minimum standard for the route. No Bike Lane signs (Austroads p12-123). Getting here relies on crossing under Lane Cove Rd from Lane Cove Park or coming south on path from De Burghs Bridge. A surface crossing of Lane Cove Road is not available. | On road line and logos need remarking as they have faded over time. Add "bike lane" signs all along the route. Provide a hook turn crossing from Eden Gardens to allow cyclists from the Lane Cove Road to turn right to Fontenoy. |

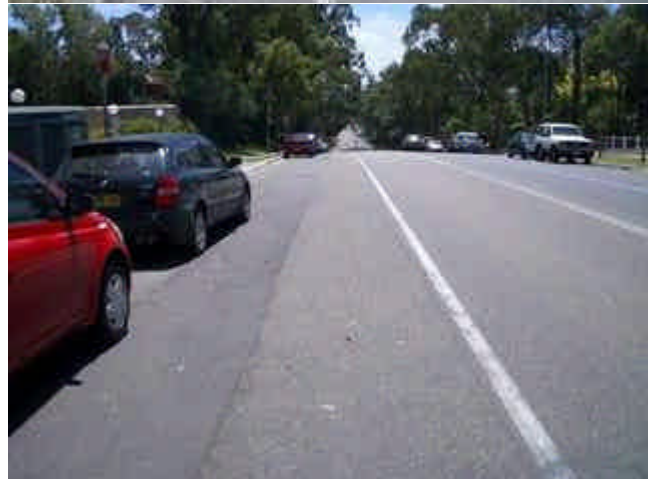
| | Location | Comments | Work |
|---|---|---|--|
| | 2. Fontenoy Rd (facing west) | With this width a "safety strip" bike lane marking should be implemented for safety from car doors and from moving vehicles. (Austroads p128,130) Existing bike lane painted line is fading due to age. | Remark on road bike lanes using "safety strip" design. |

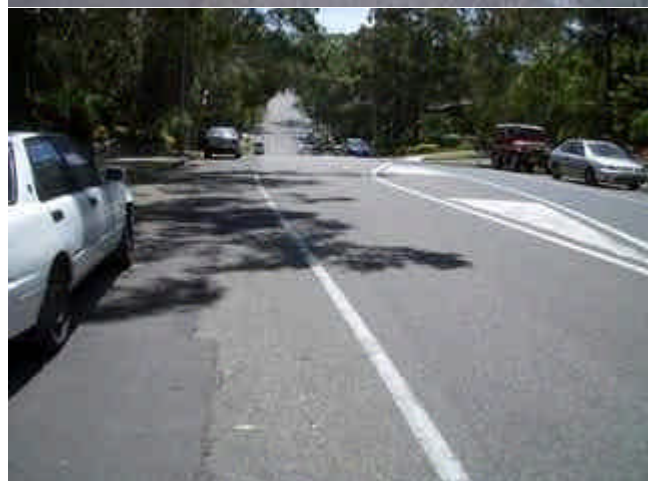
| | Location | Comments | Work |
|---|---|---|--|
| | 3. Fontenoy Rd approaching Tuckwell Place (facing west) | Bike lane narrows to allow for blind right turn bay over hill crest. Parking should be banned and "safety strip" marking bend out at this point. | Ban parking. Remark on road bike lanes using "safety strip" design. |

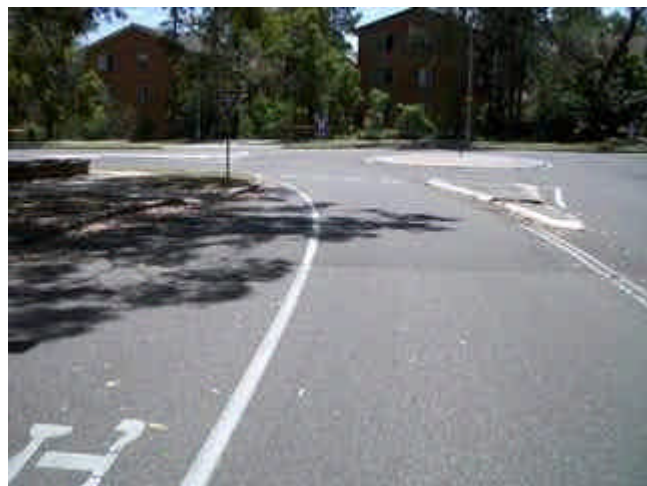
| | Location | Comments | Work |
|---|--|--|--|
| | <p>4. Fontenoy Rd approaching Khartoum Road corner (facing west)</p> | <p>Turn left at single lane roundabout. Options for cyclists to choose by ability. 1. Remark bike lane to encourage cyclists to merge into carriageway. 2. Bike lane bypass lane built around the corner taking some path and with median separation from road (Austroads p35, Fig 4-20, NSWBG p49-50)</p> | <p>Add bike logos in centre of road. Change to dashed line to encourage bike safe merging to centre of road. Add "give way to cyclists" signs.</p> |

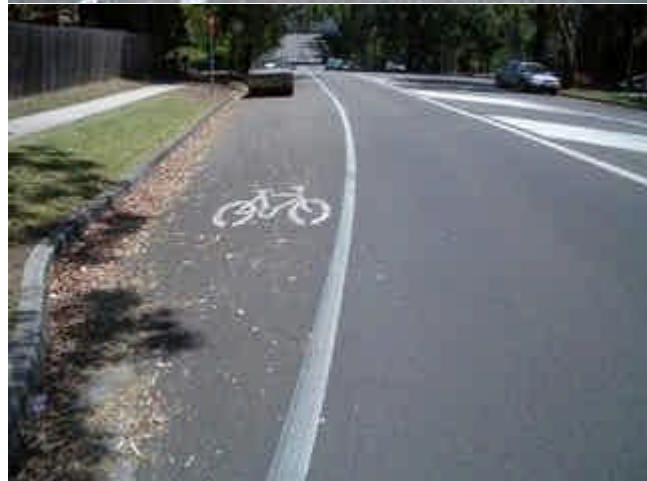
| | Location | Comments | Work |
|---|--|--|--|
| | <p>5. Khartoum Road leaving Fontenoy intersection (facing south)</p> | <p>Good bike lane facility in 50 kph zone. Faded paint. Bike lane bypass would come through kerb on the left of the photo.</p> | <p>Remark on road bike lanes using "safety strip" design.</p> |

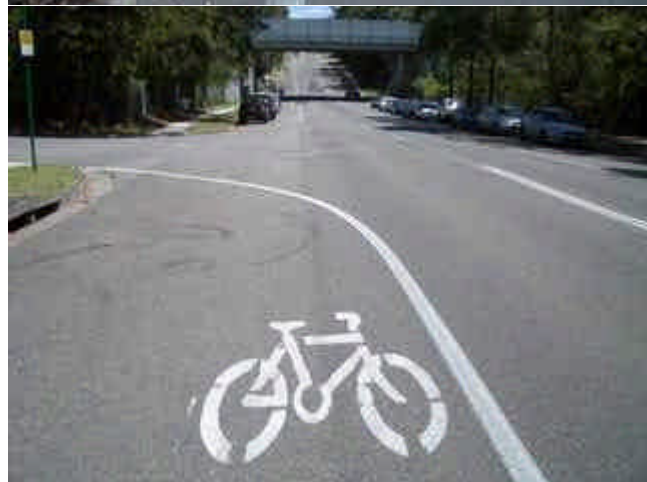
| | Location | Comments | Work |
|---|--|--|--|
| | <p>6. Khartoum Road at Tasman Place corner (facing south)</p> | <p>Bike lane disappears which is an old style treatment. Remark with broken continuity line across intersection to give cyclist a clear place to ride. (Austroads p49) This model should be used for all major/minor unsignalised intersections along the entire route.</p> | <p>Remark on road bike lanes incorporating broken continuity line marked right across the intersection.</p> |

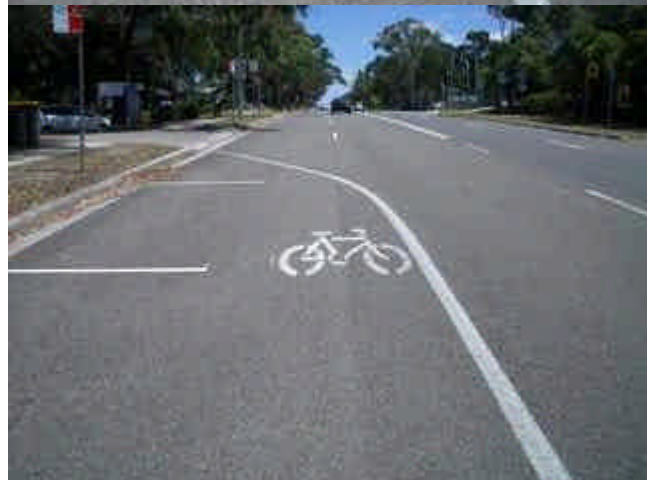
| | Location | Comments | Work |
|---|--|--|--|
| | <p>7. Khartoum Rd approaching Talavera Rd corner which has traffic signals. (facing south)</p> | <p>Safety Hazard and difficult situation. Bike lane veers to kerb but bikes need to turn right from right lane or hook turn from left lane. New lane markings should bring bike lane down centre and continuity lines and logos lead there. Right lane is not right turn only. (Austroads p56, 5-15(d).) Signage to indicate right turn ahead.</p> | <p>Remark car and bike lanes to allow for all movements as per Austroads example given.</p> |

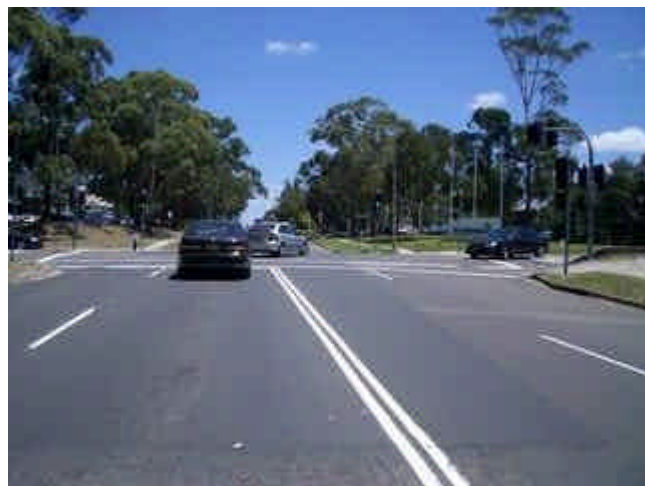
| Location | Comments | Work |
|---|---|---|
| 8. Khartoum Rd approaching Talavera Rd corner which has traffic signals. (facing south) | Safety hazard. Continuation of previous treatment up to the intersection. (Austroads p53-59) Right lane is straight/ right and left lane is straight/ left, so this is a difficult situation for a turning cyclist. Incorporate a hook turn bay on Talavera Rd westbound. (Austroads p55-57, NSWBG p57, Fig 7.19.) | Remark car and bike lanes to allow for all movements as per Austroads example given. Mark hook turn bay as indicated in NSWBG. |

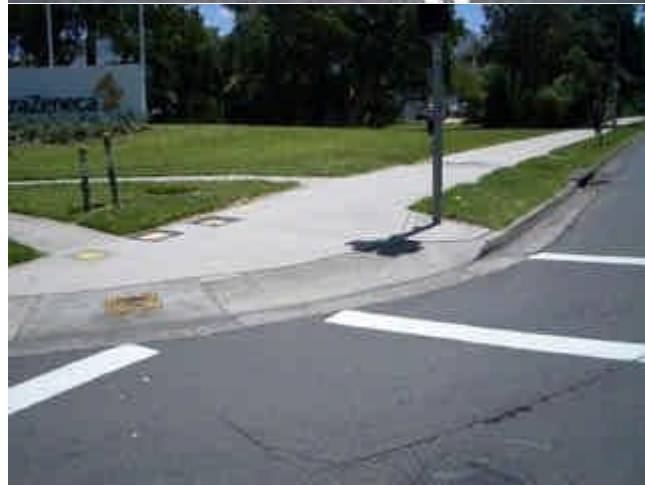
| Location | Comments | Work |
|---|---|---|
| 9. Talavera Rd at Khartoum Road corner (facing west) looking to shared user path. | Safety hazard. Cyclists have a choice to access to the shared user path via this kerb ramp or to continue on road. Very busy with pedestrians at lunch times. Line markings should run through this section to show bicycle path in both directions. Path is not wide enough at peak periods. Also mark bike lane exiting intersection westbound down Talavera. | Mark bike lane and path onto and along this kerb ramp. Widen path to 3m. Add signs for bike path and behavioural signs (NSWBG p39). Mark bike line along road with logos. |
