Appendix 4. Photo Survey, Safety and Compliance Audit - Waterloo Rd (west) Shared User Path
 (Nothing in this report indicates that cyclists accept this route as a reasonable or safe alternative to the existing M2 cycle facility.)

This is Appendix 4 of the Bike North Audit of the M2 Interim Bicycle Detour as proposed by Transurban. It covers the Waterloo Rd (west) Shared User Path (SUP) from Culloden Road to Vimiera Road. Other appendices will cover various sub routes and options that were suggested. This document should be read in conjunction with the other documents.

Principal Auditor : Doug Stewart (Bike North). Audit Date: 16 January 2007.

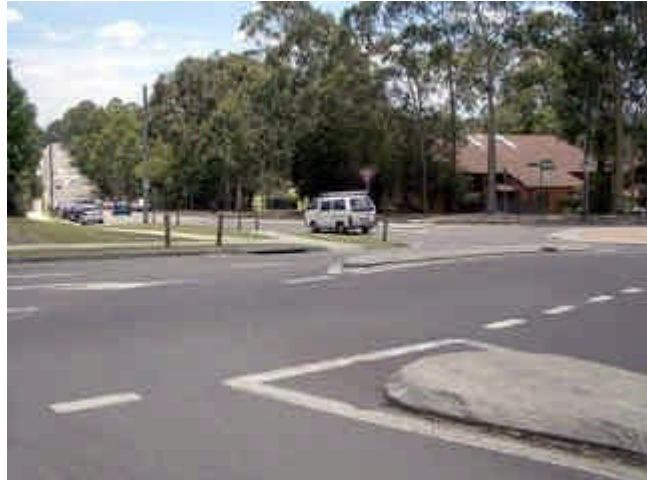
1. Waterloo Rd, Culloden Road and Gymnasium Road Corner. Start of path. (facing west) Refer to Appendix 1 photo 60.	Safety hazard. Impossible access to the start of the path, which is in the centre of the photo. Cut in median is not wide enough. Median is not wide enough, minimum 2m. (NSWBG p46) No obvious path from Culloden Road to join the path. Road crossing too close to roundabout, minimum 6m. Needs redesign. (Austroads p65-66)	Redesign access to path from Culloden Rd by creating an off road path adjacent to Culloden and then a right angle crossing back from roundabout with a wider median with a wider gap.

This short section of path will not be used by cyclists travelling long distances but may be used by local cyclists. The design at the start of the path (photo 1) must be remedied in all cases. The most likely route for cyclists who are travelling long distances such as back to the M2 would be to follow the roadway as detailed in Appendix 1.

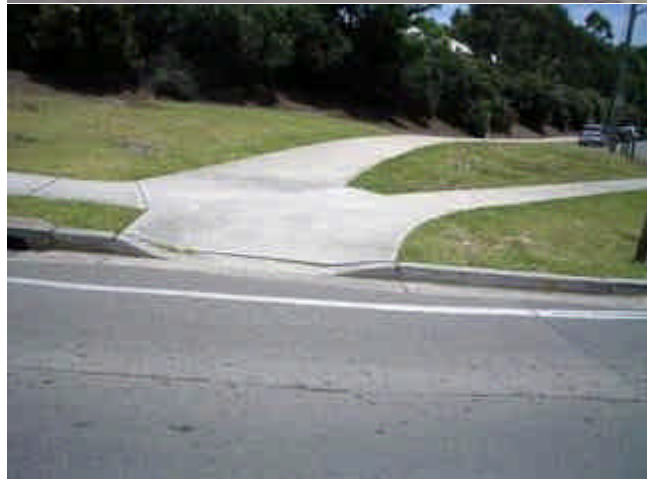
2. Waterloo Road Shared User Path (SUP) at the junction with Culloden Road. Start of path. (facing west)	To meet regional path requirements this path should be widened to 3m with centre line and logos. There is no shared path signage. The path is offset from the kerb ramp and should be aligned when path is widened.	Widen and align path. Provide line markings, logos and shared path signs.

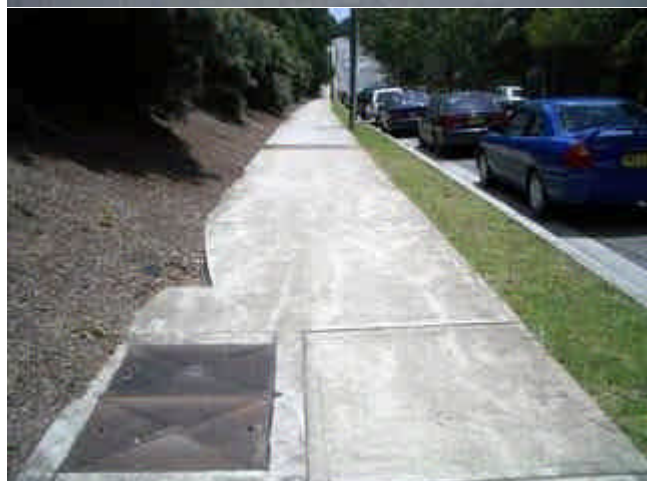
3. Waterloo Road SUP (facing west)	The path has a section missing which should be remedied	Fill missing path section.

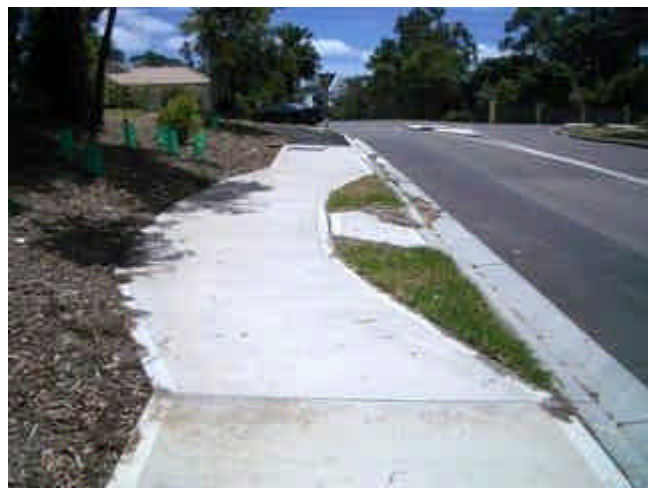
8. Waterloo Road SUP approaching Vimiera Road (facing west)	Path deviates around a kerb ramp and crossing point. Needs line marking to take account of crossing pedestrian traffic.	Line marking

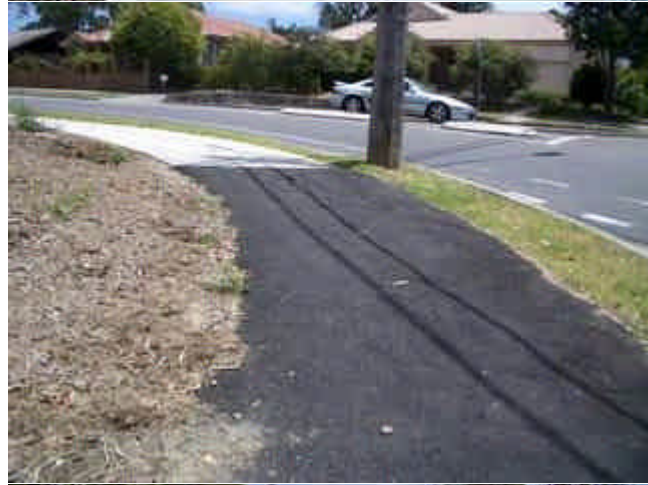
9. Waterloo Road SUP at the corner with Vimiera Road (facing west)	Asphalt surface is rough and looks like a temporary solution that should be remedied. Debris is washing down onto path from the high ground to the left and surface needs regrading to allow drainage down from path into a slight depression. Pole needs reflective material.	Install smooth concrete path. Regrade path when path is widened to allow drainage away from path. Install reflective material on pole.

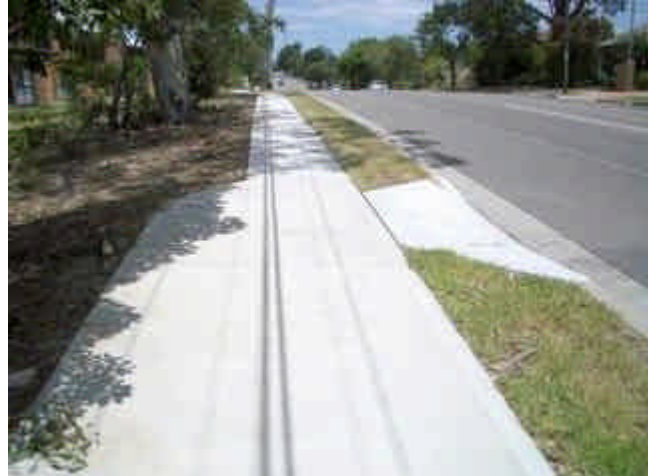
10. Vimiera Road SUP just south of Waterloo Road. End of path. (facing south)	This is the end of the shared path. Transition to road is too abrupt requiring a sharp left turn. This should be changed to a 45 degree angle transition at least 1.2m wide. (Austroads p36.)	Redesign transition to allow for angled access to the bicycle lane on the road.
