Appendix 6. Photo Survey, Safety and Compliance Audit - M2 shoulder existing route

This is Appendix 6 of the Bike North Audit of the M2 Interim Bicycle Detour as proposed by Transurban. It covers the existing sealed shoulder/cycle lane on the motorway and is included to give a comparison with other routes. This document should be read in conjunction with the other documents.

Principal Auditor : Doug Stewart (Bike North). Audit Dates: 14 January 2007, 16 January 2007, 30 January 2007,

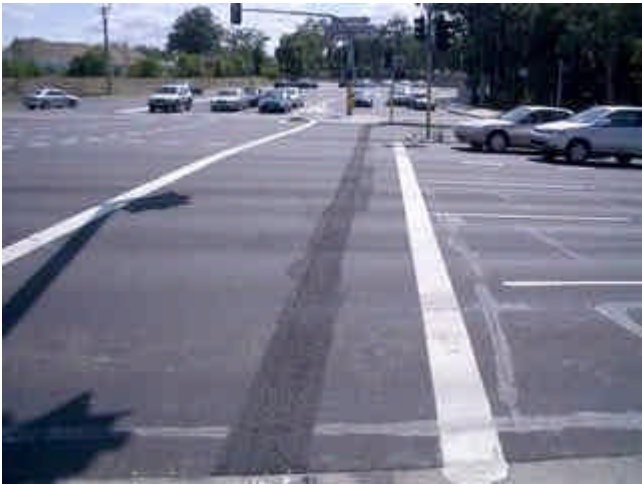
1. Epping Road and Delhi Road corner. Cycle crossing of Epping Road. (facing north)	New cycle light crossing. Delay can be long due to priority given to Epping Road.	None

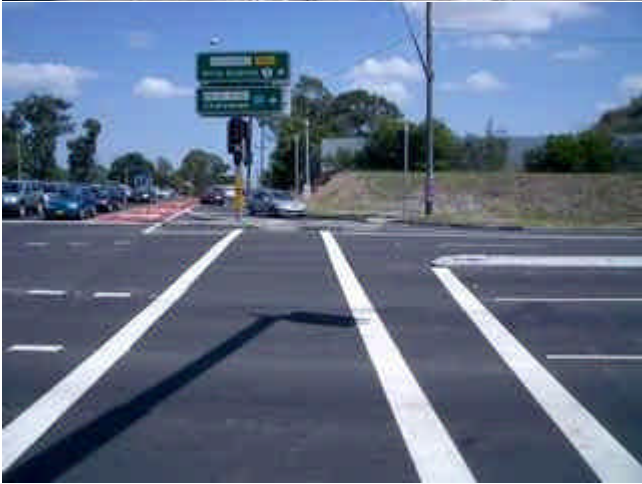
2. Epping Road and Delhi Road corner. Cycle crossing of Delhi Road. (facing west)	Need cycle light crossing and kerb ramp widened on the west side. Crossing over slip lane should be included in a single phase.	Add cycle light and widen kerb ramp.

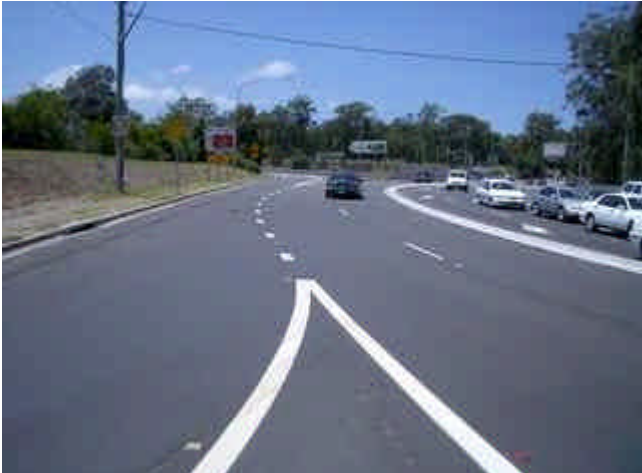
3. Delhi Road at Epping Road corner. (facing north)	Cycle lane has been removed from the left of this road. This should not have happened. We presume that the RTA anticipated removal of westbound cycle lane some years ago, but did not advise cyclists.	Widen kerb lane (or resume some nature strip) and reinstate cycle lane leading to the M2.

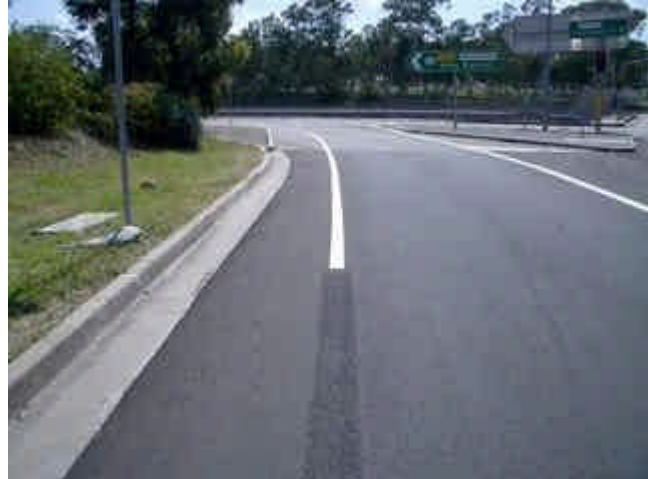
<p>4. Delhi Road slip lane onto the M2 motorway. (facing north)</p>	<p>M2 cycle lane begins.</p>	<p>None</p>

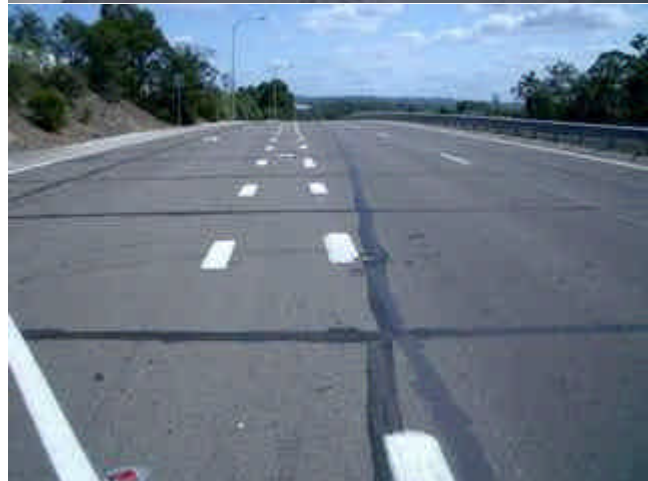
<p>5. M2 Motorway cycle lane, (facing west)</p>	<p>Cycle lane should be wider and left turn to works depot should be narrower.</p>	<p>Widen cycle lane.</p>

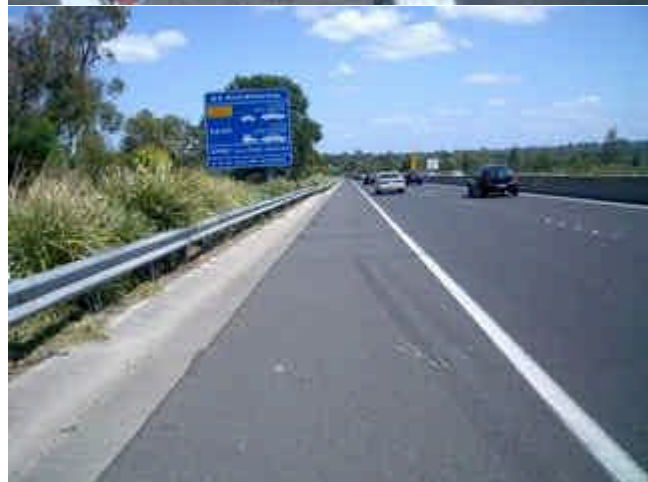
<p>6. M2 Motorway cycle lane, (facing west)</p>	<p>2.5m wide cycle lane.</p>	<p>None.</p>

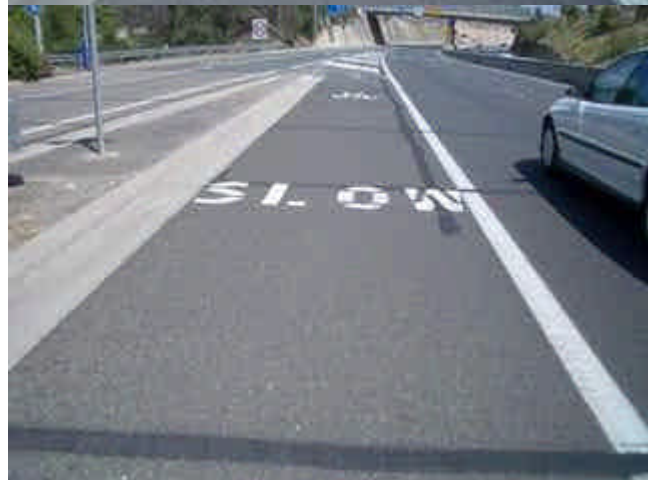
<p>7. M2 Motorway cycle lane at on Herring Road on ramp, (facing west)</p>	<p>Cycle lane with standard crossing point.</p>	<p>None</p>

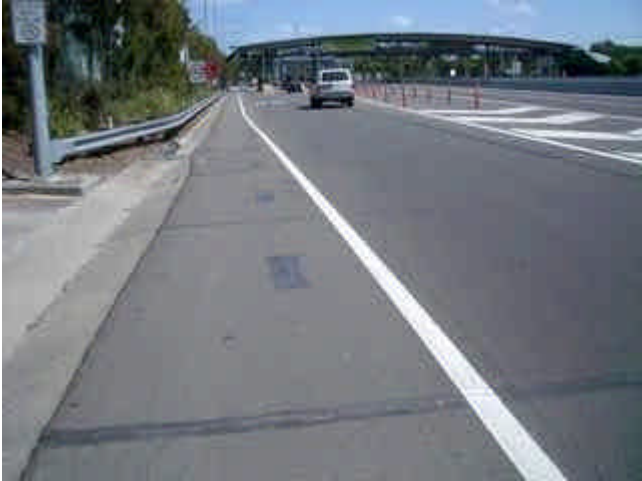
<p>8. M2 Motorway cycle lane, approaching toll plaza (facing west)</p> <p>Cycle lane narrows as the toll plaza is approached.</p>	<p>Cycle lane should be kept at a consistent 2.5m.</p>

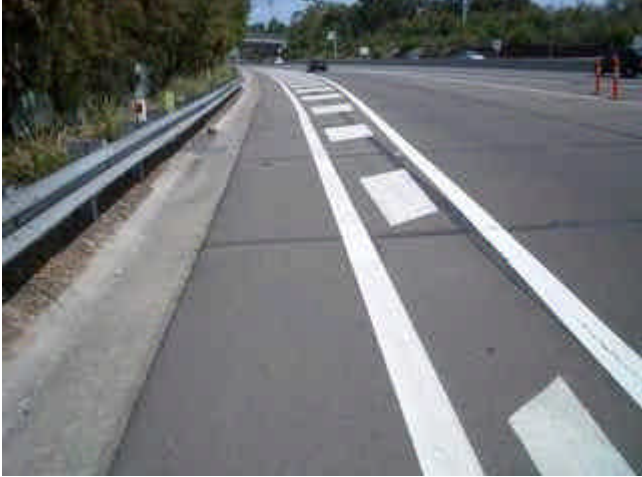
<p>9. M2 Motorway cycle lane, leaving toll plaza (facing west)</p> <p>2.5m wide cycle lane. Narrow cycle lane continues leaving the toll plaza but this painted buffer strip is very welcome. Painted buffer strip should be considered the entire length of the M2 Motorway, to encourage separation by taking 0.5m from the cycle lane. Vehicle side only should be Vibraline.</p>	<p>Cycle lane should be kept at a consistent 2.5m.</p>

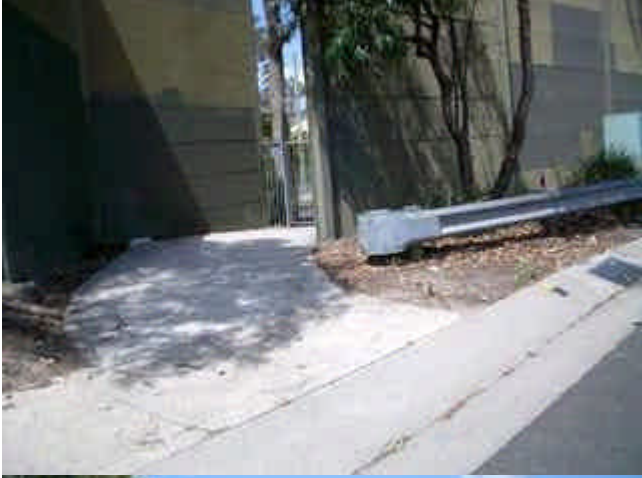
<p>10. M2 Motorway cycle lane, at Vimiera Road cycle entry/exit (facing west)</p> <p>This entry point allows for local access and there should be many more of these along the length of the M2. This would facilitate use of M2 by many more cyclists. Other locations should be considered for cycle-only access points.</p>	<p>None.</p>

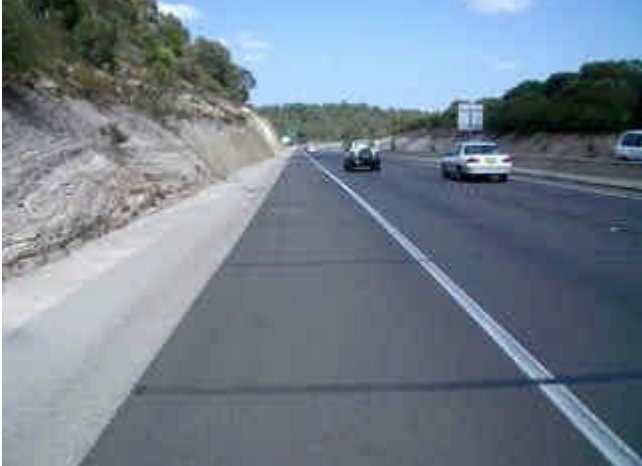
<p>11. M2 Motorway cycle lane, (facing west)</p> <p>2.5m wide cycle lane.</p>	<p>None.</p>

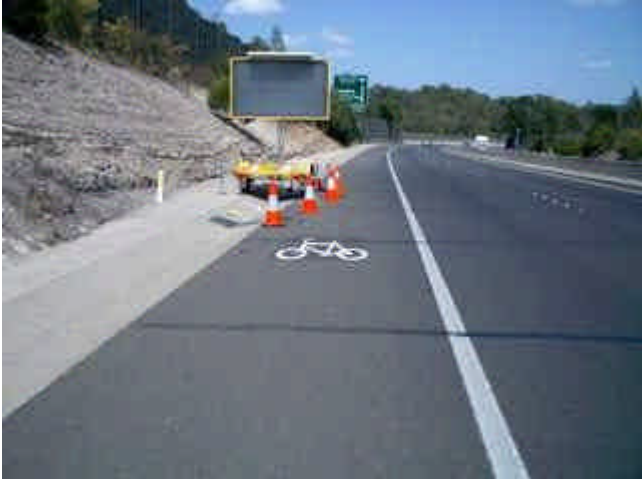
<p>12. M2 Motorway cycle lane, (facing west)</p> <p>M2 operators often block parts of the cycle lane to a greater or lesser extent. This has improved recently by use of reflective cones, but practices can still improve in siting these signs. Obstacles should be 1m clear of the cycle lane. (Austroads p72)</p>	<p>If possible do not place obstacles on the 2.5m wide cycle lane.</p>

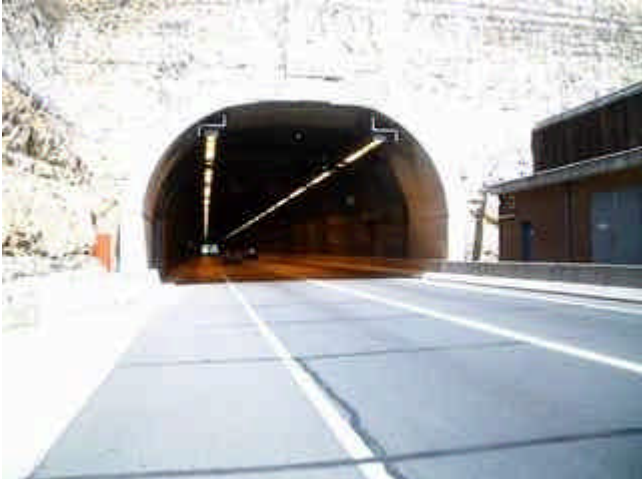
<p>16. M2 Motorway cycle lane, at Norfolk Road Tunnel portal (facing west)</p>	<p>2.5m wide cycle lane. None.</p>

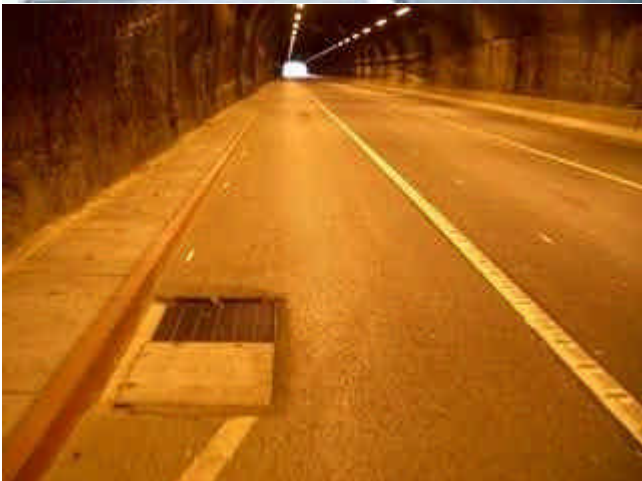
<p>17. M2 Motorway cycle lane, inside Norfolk Road Tunnel (facing west)</p>	<p>The cycle lane is effectively narrowed by the drains installed. Although most drains have entry and exit ramps they need improvement and should be even shallower. (Austroads p116-119) The paint dots show the proposed 3 lanes with the tunnel escape route being the raised footpath on the left. Consistently reduce lips and gradients in and out of all the grates to a smooth surface.</p>

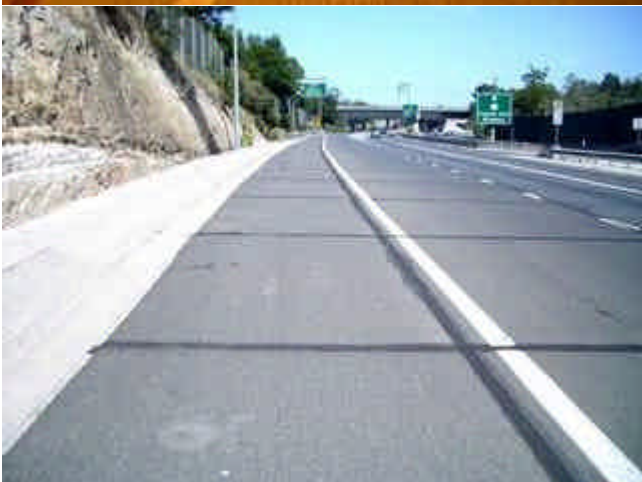
<p>18. M2 Motorway cycle lane, leaving the Norfolk Road Tunnel (facing west)</p>	<p>2.5m wide cycle lane. None.</p>

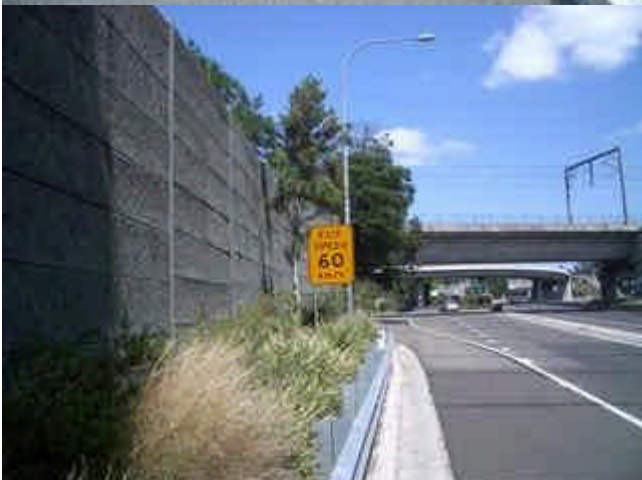
<p>19. M2 Motorway cycle lane, at Beecroft Road off ramp (facing west)</p>	<p>2.5m wide cycle lane and then a mergere where continuing cyclists merge to the right. None</p>
